MUD STRUCTURES IN THE HARBOROUGH AREA

Rosalind M Willatts

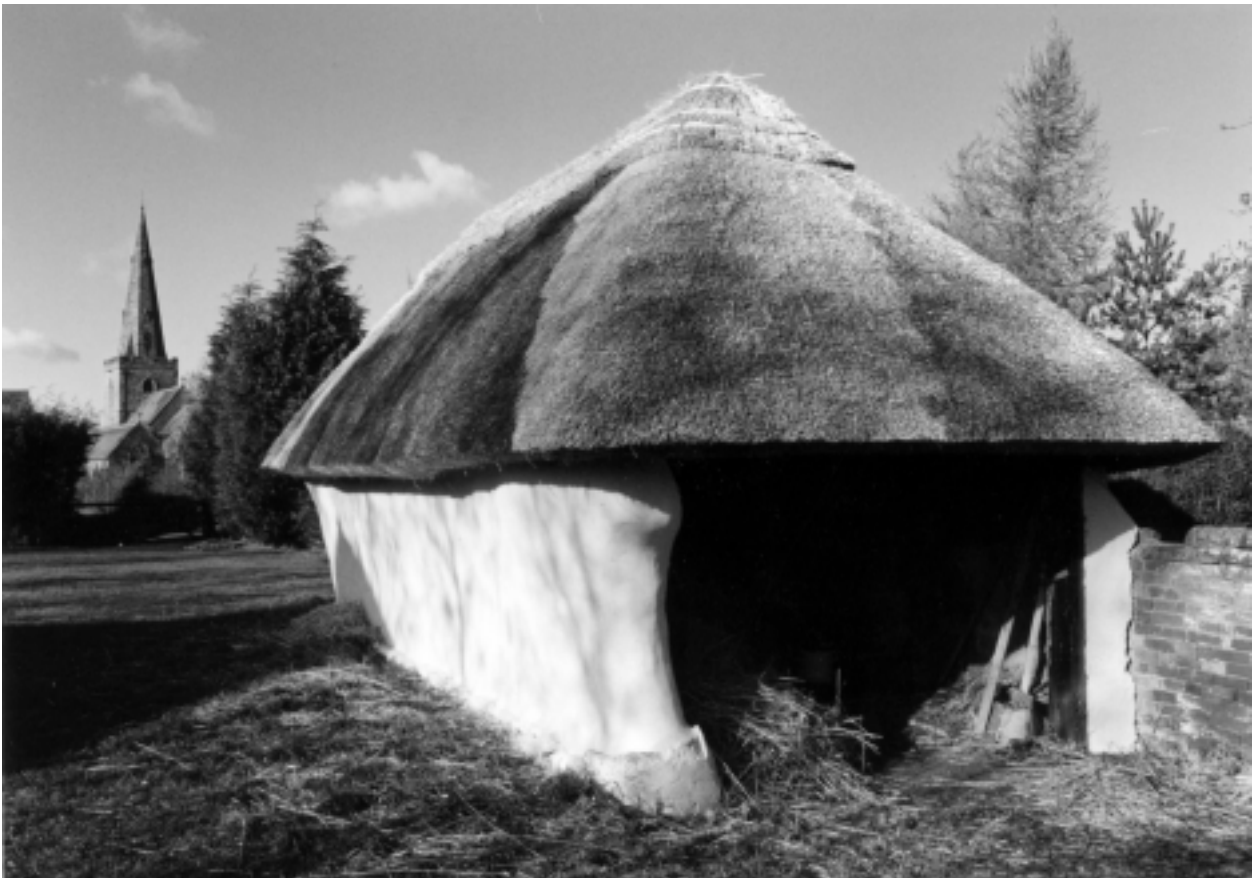
HOVEL AT GILMORTON RESTORED IN 1996.

Whole (or almost whole) subsidiary buildings in mud are found at the Hovel in Gilmorton and in the little slaughterhouse lairage attached to the west churchyard wall at Laughton. The hovel is particularly interesting as a survival of a building type that must once have been widespread in the local area. It is small, perhaps 3m x 7m open at one end, with three

walls of mud and a hipped thatched roof. A hipped roof is structurally more stable than building up pointed gable in mud. Its use was as a field shelter for animals. (Open fronted brick or stone field shelters of the nineteenth century are still readily found across the local

landscape) This little building was used for general storage and was not carefully maintained. In 1987 its existence was threatened by proposals to develop its field with houses. In the event houses were built on the adjacent land and the hovel was spot-listed as a building of special architectural or historic interest. In 1996 a new owner of the field and hovel had it repaired and re-thatched: the roof structure was tied into the mud walls with steel rods, the mud repaired – it had a few cracks and had been worn away in parts by rubbing – the walls were covered with a mud plaster and limewashed. Once again this building is used for sheltering animals.

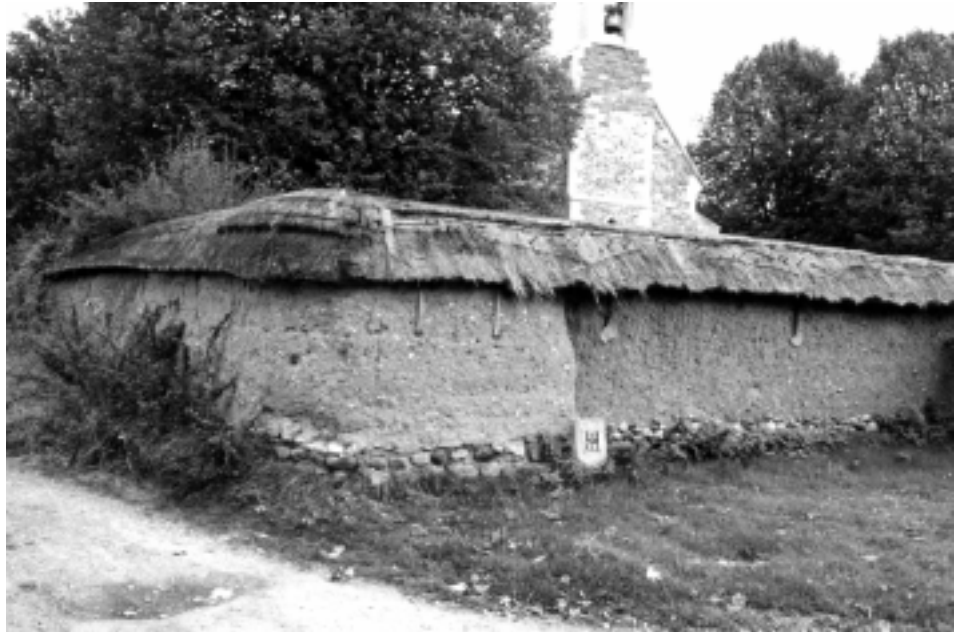
LAUGHTON CHURCH WALL.

Mud buildings need a good hat and a good pair of boots both of which are important to keep the structure dry. For walls the 'hat' can be of thatch (Laughton churchyard) or slate (Crox farmyard Tur Langton) or of pantiles (Great Bowden and Foxton churchyards). Sometimes a temporary repair has been made with corrugated iron as on the churchyard walk at South Kilworth and the Berries farmyard at Swinford. The 'boots' are a plinth of river cobbles or stone. The walls of mud buildings are 500 – 600mm thick, often slumped at the

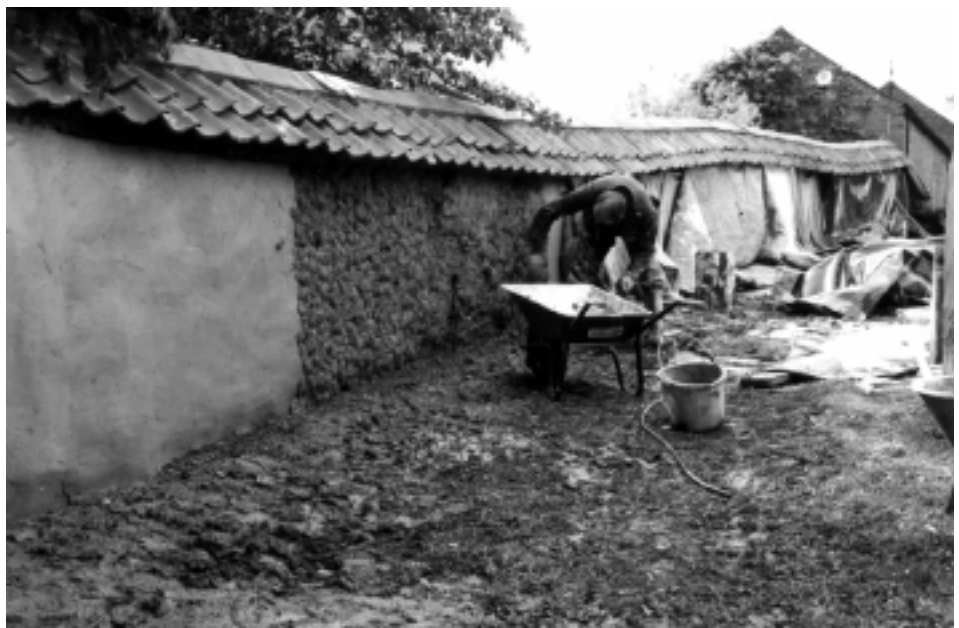
FOXTON CHURCH WALL 1998.

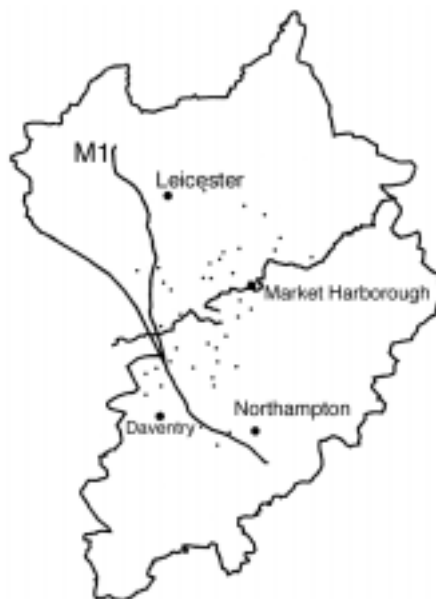
SELECTED VILLAGES WITH MUD BUILDINGS. THE AREA COVERED BY HADES IN LEICESTERSHIRE AND NORTHAMPTONSHIRE: THE NORTHAMPTONSHIRE VILLAGES ARE MAINLY ABOVE 150M AND ON THE LIAS CLAYS AND SANDS LYING ON TOP OF THE JURASSIC LIMESTONE: THE LEICESTERSHIRE VILLAGES ARE MAINLY ON THE LOWLANDS OF THE LOWER LIAS CLAYS.

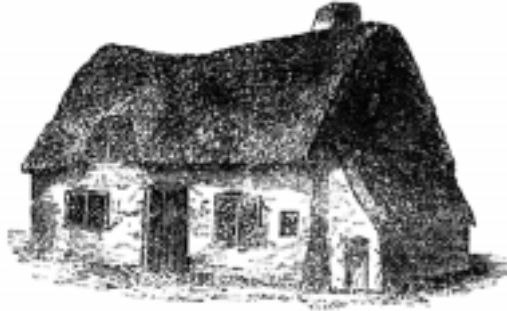
MUD COTTAGES AT
GREAT BOWDEN 1849.

Mud is locally found in three ways: as complete buildings including cottages and walls; as remnant parts of older buildings that have been repaired or substantially rebuilt in other materials; and as infill panels of timberframe buildings both externally and internally. The only example of mud in Market Harborough at present known to the writer is in an internal timberframed cross wall in Aldwinkles yard behind Church Street. But there are many examples in both Great and Little Bowden.

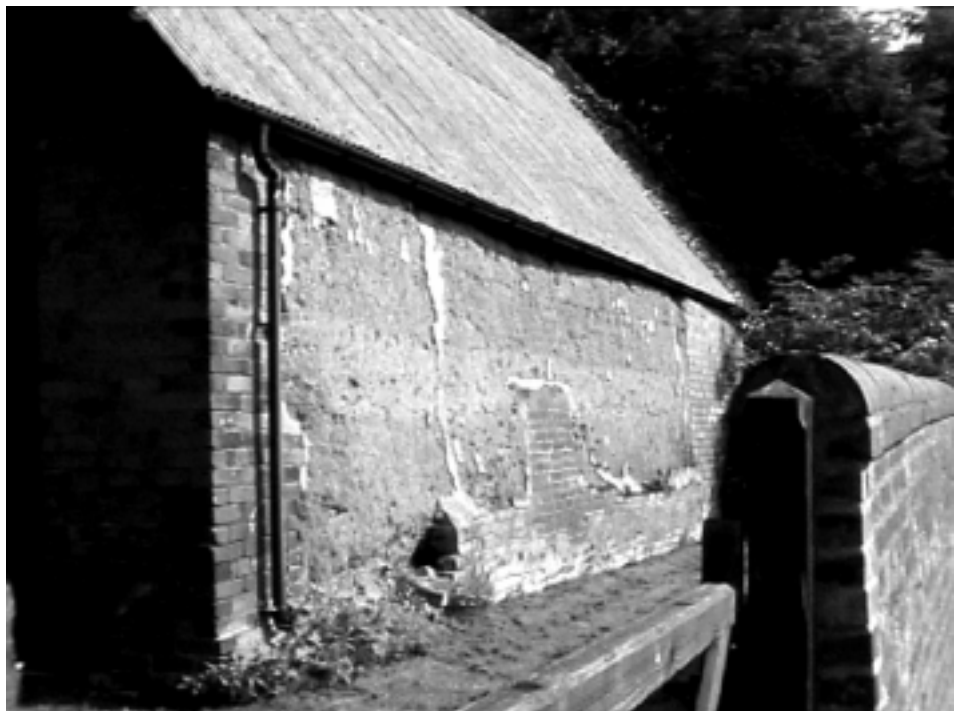
MUD BARN WALL AND TIMBER
BEAM INCORPORATED INTO A
MODERN STRUCTURE AT
GREAT BOWDEN JULY 2000.
