MUD STRUCTURES IN THE HARBOROUGH AREA

Rosalind M Willatts

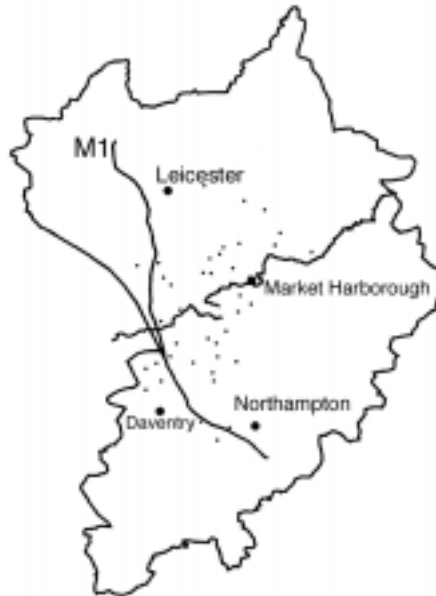
SELECTED VILLAGES WITH MUD BUILDINGS. THE AREA COVERED BY HADES IN LEICESTERSHIRE AND NORTHAMPTONSHIRE: THE NORTHAMPTONSHIRE VILLAGES ARE MAINLY ABOVE 150M AND ON THE LIAS CLAYS AND SANDS LYING ON TOP OF THE JURASSIC LIMESTONE: THE LEICESTERSHIRE VILLAGES ARE MAINLY ON THE LOWLANDS OF THE LOWER LIAS CLAYS.

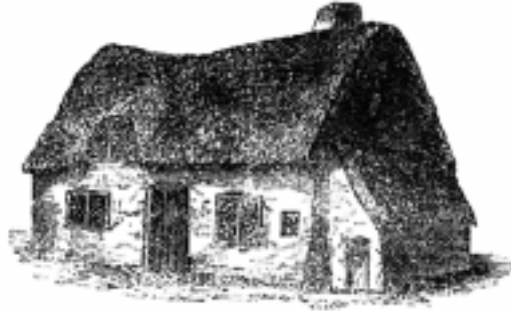
MUD COTTAGES AT
GREAT BOWDEN 1849.
